7 County Home Inspection, LLC Home Inspection Report

2345 Anywhere Street, Meridian, ID 83646 Inspection prepared for: Jerry Doe & Samantha Doe Date of Inspection: 8/8/2014 Time: 1pm Age of Home: 2005 Size: 2510 Weather: Sunny

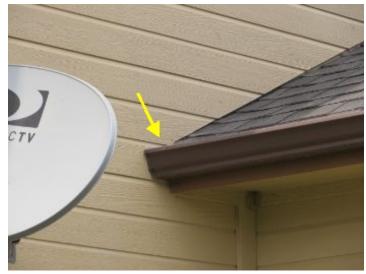
| EXTERIOR AREAS | | | | | |
|---|---|--|--|--|--|
| Page 4 Item: 1 | Roof | • **Kickout flashings needed at roof to wall junction. Consult with contractor on installing See photo | | | |

**Kickout flashings needed at roof to wall junction.

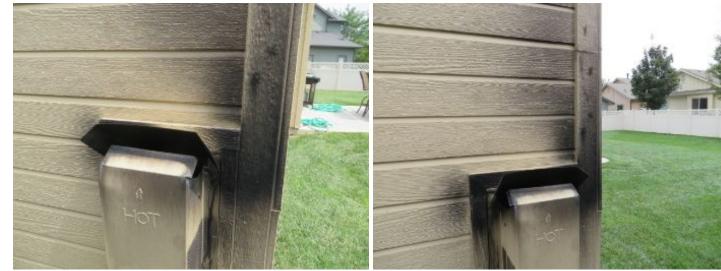
| EXTERIOR AREAS | | | | | |
|---|---|--|--|--|--|
| Page 24 Item: 10 | Fireplaces | • Fireplace may not be burning correctly. Likely needs cleaning/service. Black soot on exterior siding. Recommend consult fireplace contractor | | | |

There is an unusually large amount of black soot on siding and exterior chimney backside of home. on siding and exterior chimney backside of home. This is likely due to incomplete or inefficient burning. Recommend consult with fireplace contractor. See photos

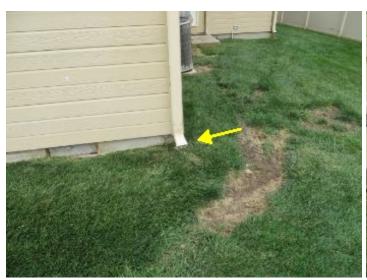
**Gutter Extensions / Splash blocks missing or insufficient: Install to divert water away from the foundation. Extensions need to extend out 4-5 feet away from structure

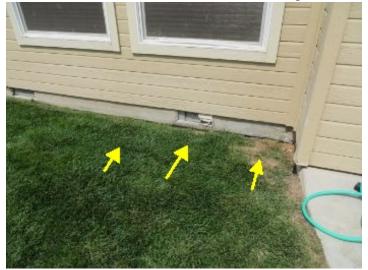
Backside of garage and home (west side)**Perimeter Grading: Appears level or sloped towards building in areas. Recommend grading soil so it slopes down and away from the building to direct rainwater away.

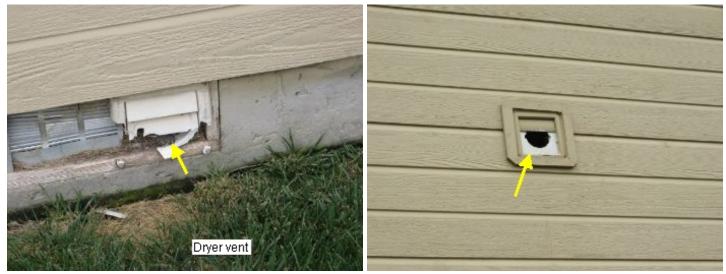
Exhaust fan vents are damaged at the back home. Exhaust fan vents are damaged at the back home. one is missing flaps and other is partly sealed and one is missing flaps and other is partly sealed and missing flaps.

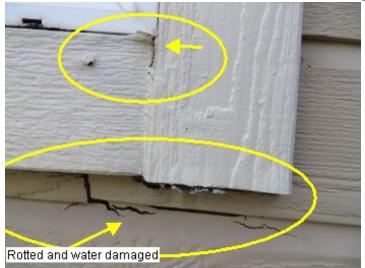
| EXTERIOR AREAS | | | | | |
|---|---|--|--|--|--|
| Page 7 Item: 5 | Siding/Foundation | • Siding under kitchen window is damaged at the corner. See photos. Recommend repair. Consult with licensed contractor on estimates/repairs | | | |

Siding under kitchen window is damaged at the corner. See photos. Recommend repair. Consult with licensed contractor on estimates/repairs

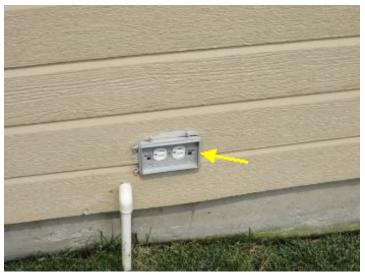
| EXTERIOR AREAS | | | | | |
|---|---|--|--|--|--|
| Page 8 Item: 8 | Exterior Electrical | OUTLETS: Exterior Outlet cover behind garage damaged. Recommend replace for safety | | | |

Exterior Outlet cover behind garage damaged.

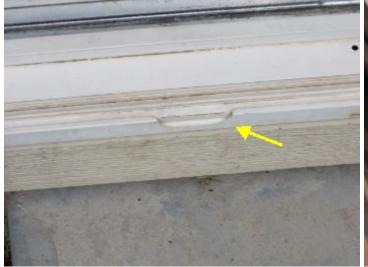
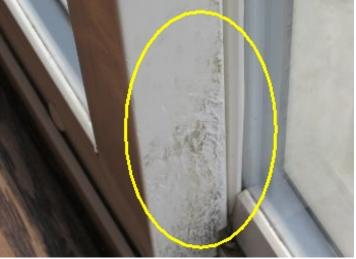
Sliding Door exterior mold of frame has a piece broken off. This is cosmetic only and does not affect the function. See photos.

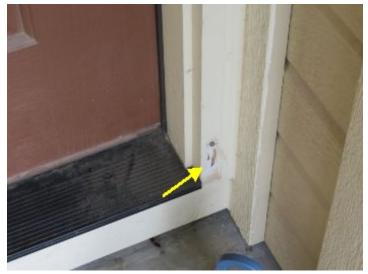
Slight trim damage at front door

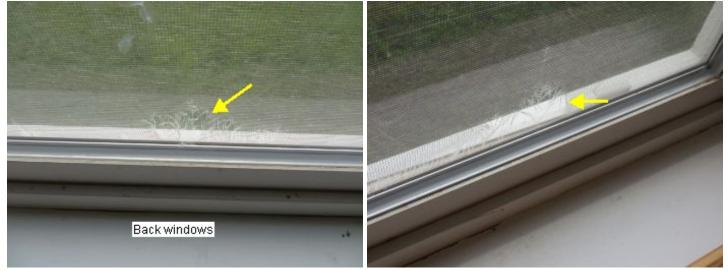
Some window screens damaged.

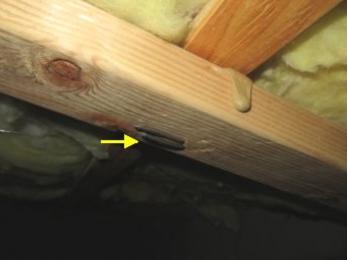
| EXTERIOR AREAS | | | | | |
|---|---|--|--|--|--|
| Page 11 Item: 2 | Crawlspace | • Support wall top plate board is missing support post. See photo. This is about 6 feet from hatch toward the front of the home. Someone has removed the vertical support board which helps support the long span of the floor joist. Need to add the vertical support 2x4 put back in place again. No sign of any interior or further structural damage at time of inspection | | | |

• Support wall top plate board is missing support post. See photo. This is about 6 feet from hatch toward the front of the home. Someone has removed the vertical support board which helps support the long span of the floor joist. Need to add the vertical support 2x4 put back in place again. No sign of any interior or further structural damage at time of inspection

Nail where support used to be

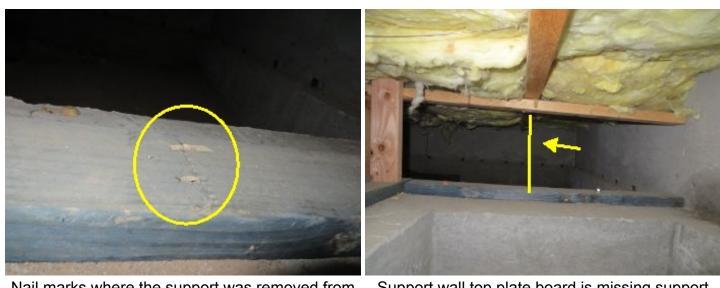
Nail marks where the support was removed from

Support wall top plate board is missing support post. See photo. This is about 6 feet from hatch toward the front of the home. Someone has removed the vertical support board which helps support the long span of the floor joist. Sagging is beginning to occur. Need to add the vertical support again.

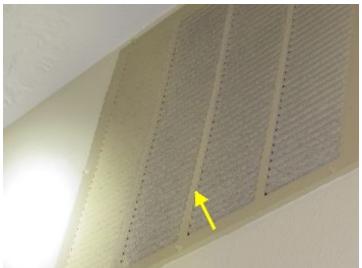
Home HVAC return duct, over the stairs is very dirty and needs cleaning. This indicates the ductwork may need cleaning as well. No filter being present in HVAC unit is likely contributing

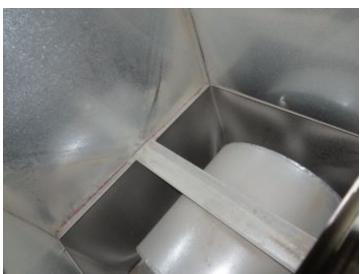
Furnace Filters are missing

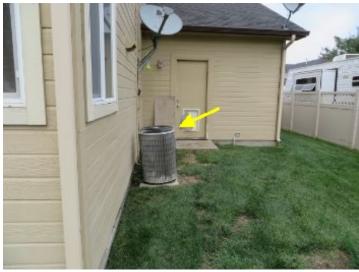
AC unit out of level. This can reduce the life expectancy of the unit and components. Recommend having leveled by licensed HVAC contractor

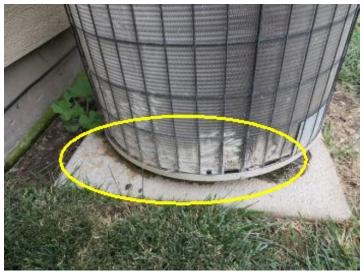
AC Unit on exterior has fin damage. This can reduce the efficiency of the unit, however the unit showed good register temperatures under Thermal Infrared imaging (54-58 degrees) at time of inspection which indicates no loss of efficiency. If unit does not run efficiently during summer, this may be the reason. Recommend consulting with HVAC contractor for repair estimates if needed. Use caution when mowing and weed eating.

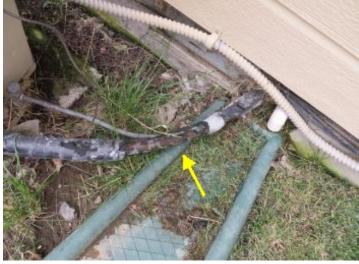
AC Unit refrigeration line insulation is damaged. This can cause damaged to the lines and unit and should be repaired.

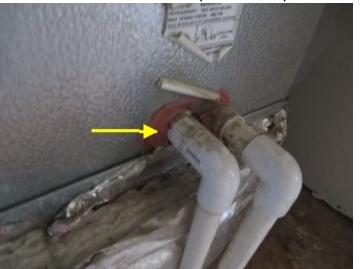
Condensate line has no water coming out

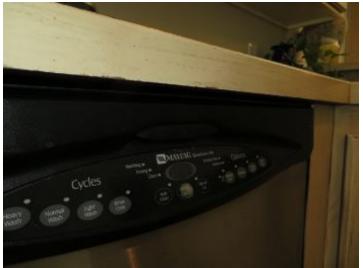
Dishwasher buttons worn and handle can be difficult to open

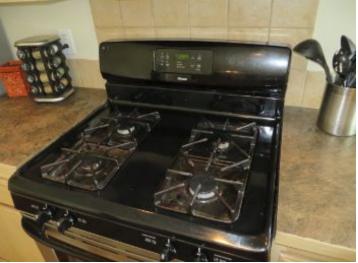
| EXTERIOR AREAS | | | | | |
|---|---|--|--|--|--|
| Page 19 Item: 1 | Kitchen | STOVE: Safety Hazard- Stove Missing anti-tip brackets. Recommend install | | | |

Safety Hazard- Stove Missing anti-tip brackets. This is needed to prevent injury or death. Recommend install prior to moving in.

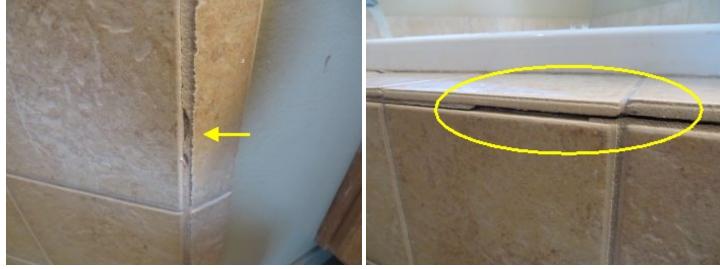
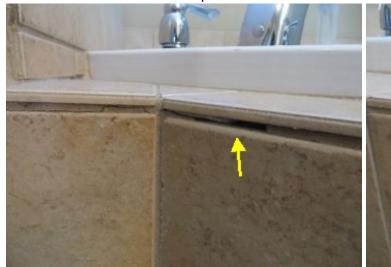
Tub tile has some damaged and missing grout in Tub tile has some damaged and missing grout in areas. See photos areas. See photos

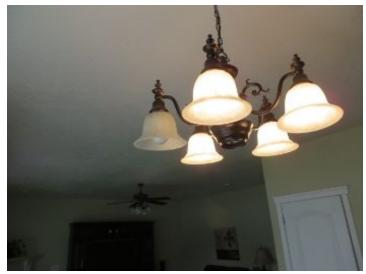
Light inoperative on dining room light. May need new bulb

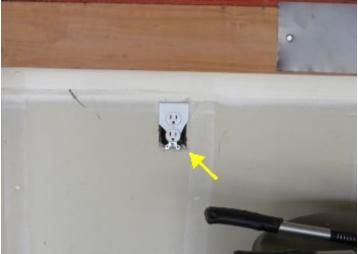
| EXTERIOR AREAS | | | | | |
|---|---|--|--|--|--|
| Page 21 Item: 6 | Interior Electric | OBSERVATION: Outlet under wood shelving has a damaged cover. Recommend replace cover for safety | | | |

Garage Safety Hazard- outlet under wood shelving has a damaged cover. Recommend replace

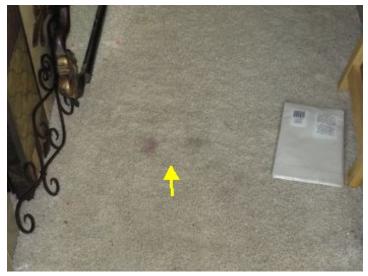
Stain in carpet in closet area under stairs

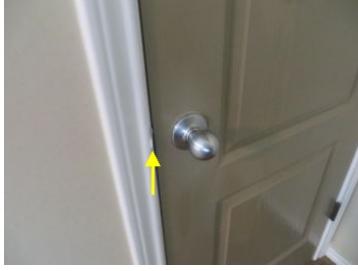
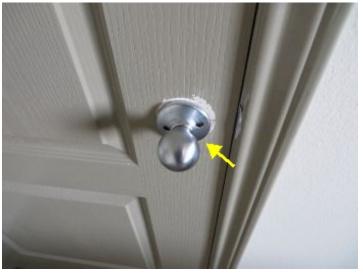
Front entry closet Door striker plate Adjustment needed, Door doesn't latch properly.

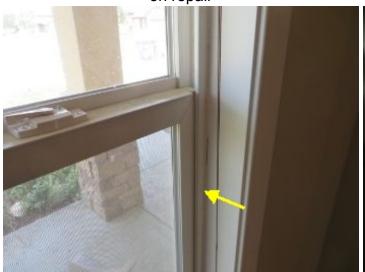
Entry Family Room front right window (from inside home) does not function correctly. Binds and is loose. tracks move and appear to be damaged. Consult with window contractor on repair

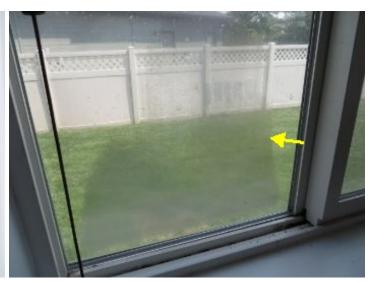
Kitchen window over sink (east side) has broken seal and fogging. Consult with window contractor seal and fogging. Consult with window contractor on repair

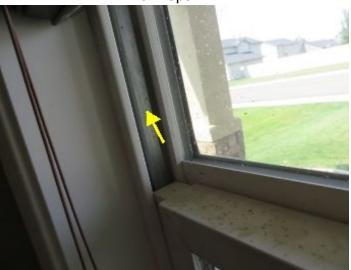
track moves with window

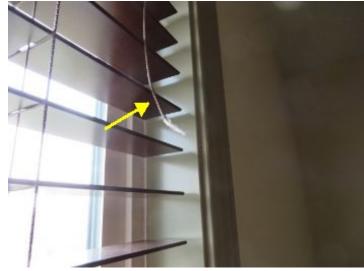
Upper back west Bedroom blind cord damaged/ string cut

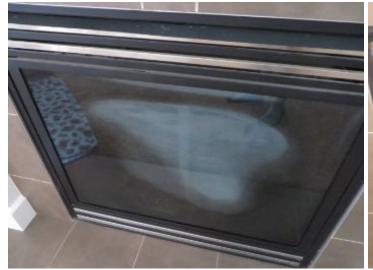
- Fireplace glass is fogged. Consult fireplace contractor on cleaning repair
