7 County Home Inspection, LLC

Home Inspection Report

1234 Home Inspection Rd, Minneapolis MN, 55418
Inspection prepared for: Great Client
Agent: ANY AGENT - ABC REALTY

Inspection Date: 4/2/2011 Time: 12pm
Age: 1990 Size: 2100sqft
Weather: Cloudy/Cold

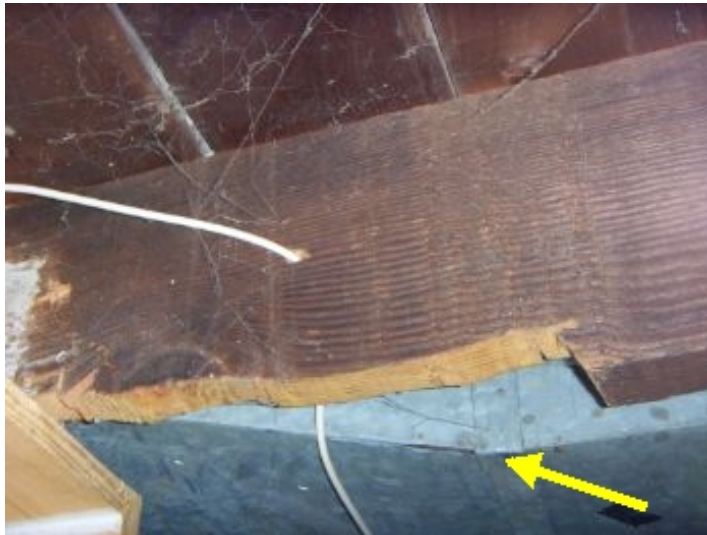
- Minor Unevenness was observed in the floor structure- This is common with older homes. It may be the result of materials, framing design, installation or age. There was no evidence of need for immediate costly repair
- Floor Joists have limited View due to finished lower level
- **Joists Notched/Cut. This can pose a structural issue or cause future damage if left unsupported. Recommend consult with contractor on adding additional support or repair.**

Joists Notched/Cut. This can pose a structural issue or cause future damage if left unsupported. Recommend consult with contractor on adding additional support or repair.

Page 4 Item: 1	Structure Observations	<ul style="list-style-type: none"> • Joists Notched/Cut. This can pose a structural issue or cause future damage if left unsupported. Recommend consult with contractor on adding additional support or repair.
----------------	------------------------	--

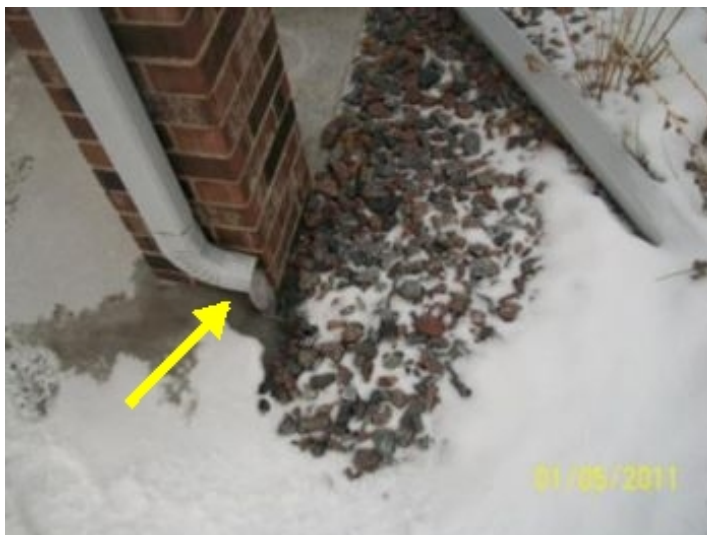
- **Snow covered landscaping restricted view; not fully inspected.
- **Clean gutters: Significant amounts of debris evident.
- **Gutter Extensions / Splash blocks missing or insufficient: Install to divert water away from the foundation. Extensions need to extend out 4-5 feet away from structure**

Gutter Extensions out 4-5 feet / Splash blocks missing or insufficient: Install to divert water away from the foundation.

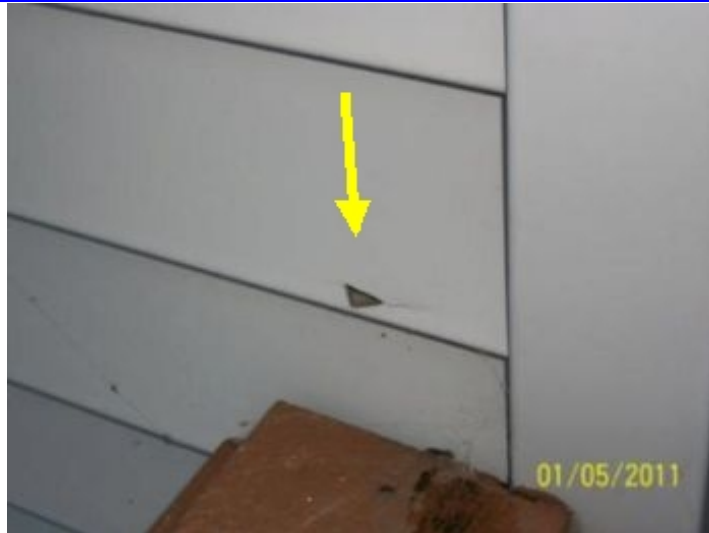
- **SIDING:**
- **Vinyl siding damage. Recommend repair or replacement of damaged sections to keep moisture and insects from harming structure.**

Vinyl siding damage. Recommend repair or replacement of damaged sections to keep moisture and insects from harming structure.

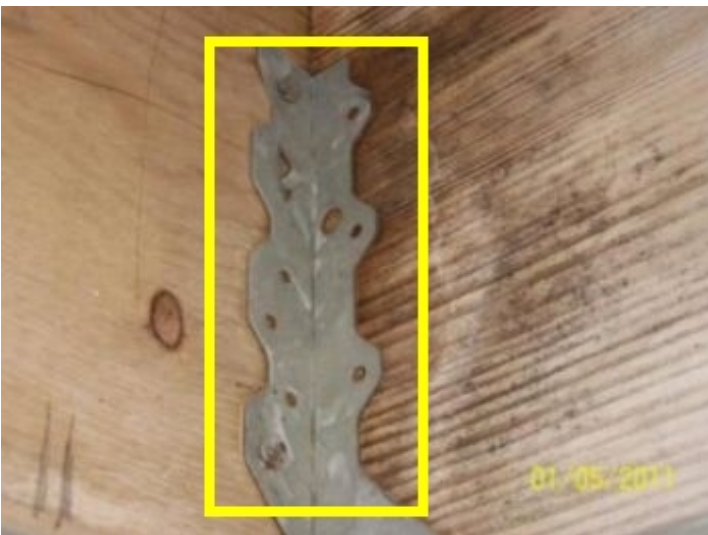
Observations:
 • MATERIAL:
 • Wood
 • Safety Hazard- Deck Joist hangers missing nails. Recommend add needed hardware. Advise with contractor.

Safety Hazard- Deck Joist hangers missing nails. Recommend add needed hardware. Advise with contractor.

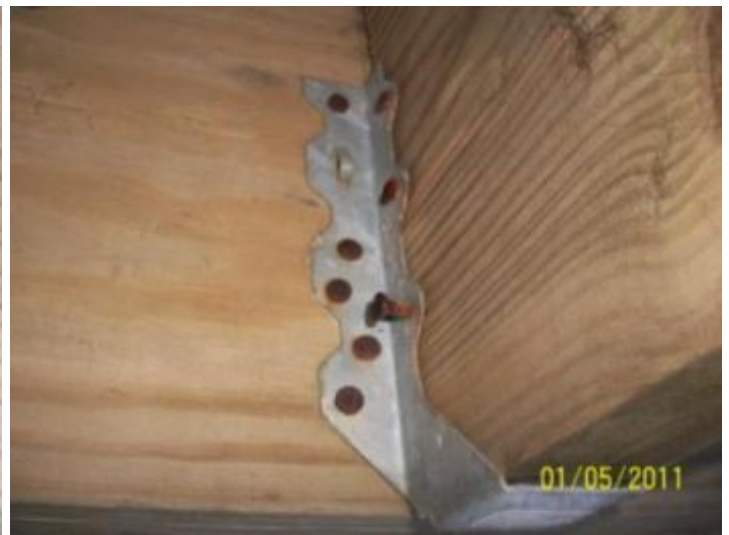
Joist hanger nails pulling out, rusting and not correct type

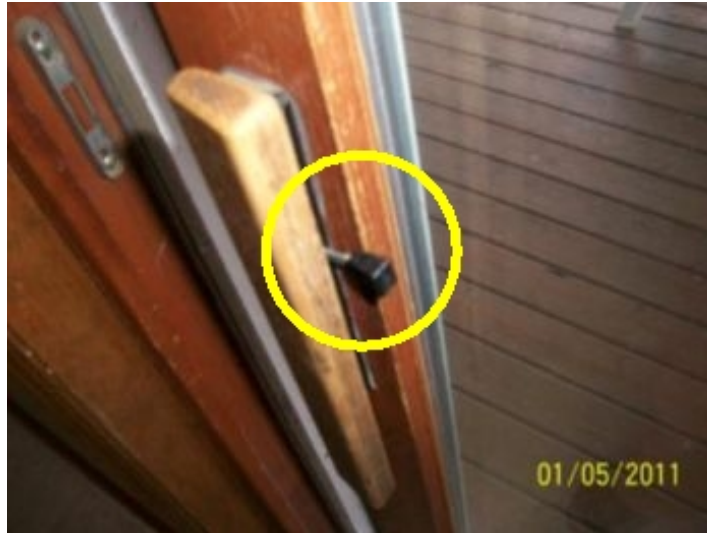
- No major system safety or function concerns noted at time of inspection.
- **SLIDING DOOR:**
- Door hardware/ lock damaged.

Door hardware/ lock damaged.

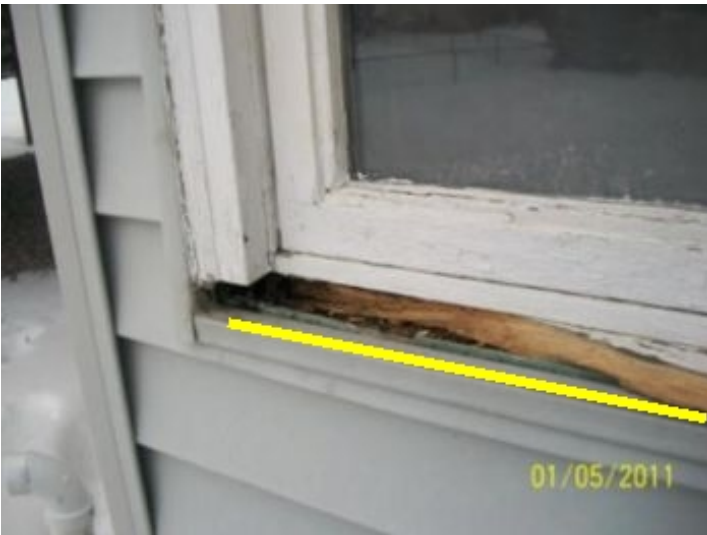
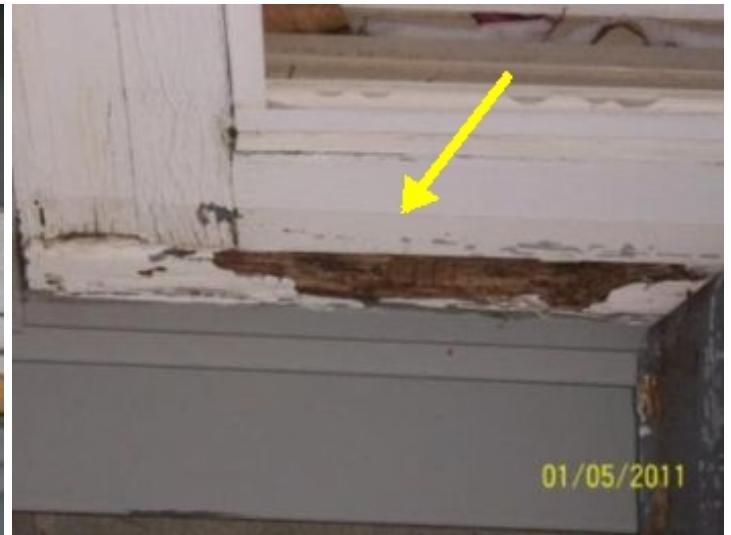
- Deteriorated frame(s) at window(s)
- Extensive rot around window frames and sills

Extensive rot around window frames and sills

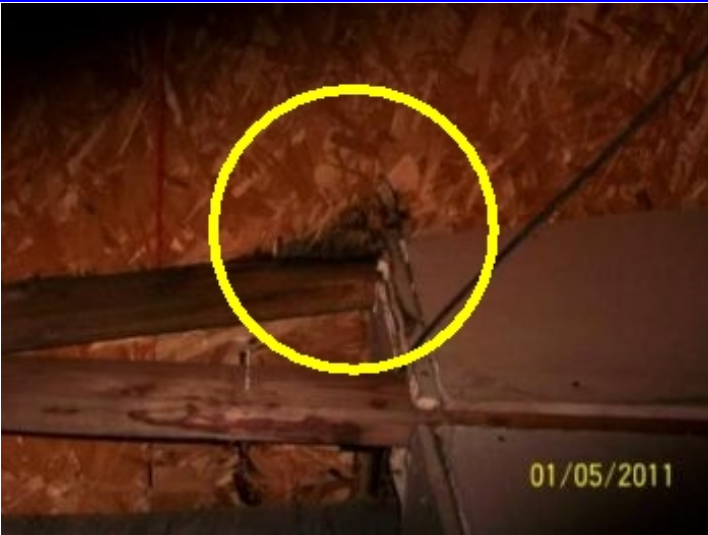
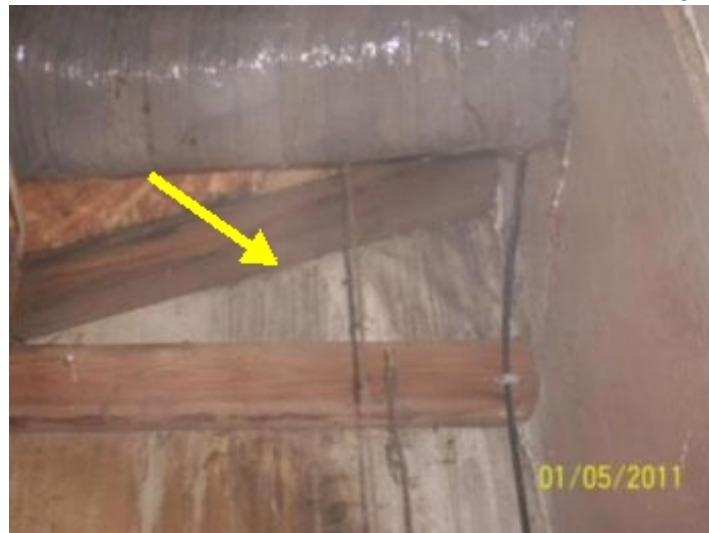
- GARAGE OVERHEAD DOOR:
- METAL
- Water seepage into garage through exterior garage-personnel door.
- Evidence of past or present leaks in garage ceiling/wall, dry at time of inspection. Monitor this area, or have it evaluated further.
- Possible organic substance noted. It is advisable to have area tested for hazardous Mold or have material professionally removed.

Evidence of past or present leaks in garage ceiling/wall, dry at time of inspection. Monitor this area, or have it evaluated further.

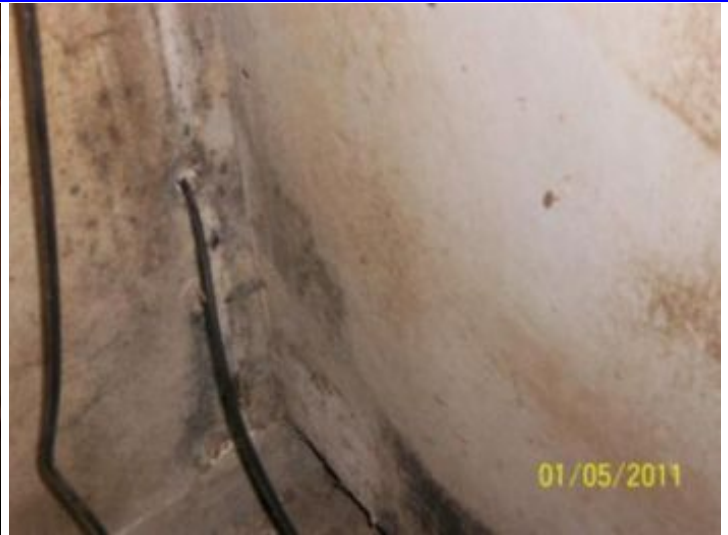
Possible organic substance noted. The United States Environmental Protection Association (EPA) states, "If you believe that you may have a hidden mold problem, consider hiring a professional." (Brief Guide to Mold, p.14, EPA). If any area of the residence is suspected of having organic growth, or any member of your family or household is sensitive to mold, we are lab-certified to conduct a Mold Inspection / Sampling to identify the types of mold (or any other airborne allergens) present. If necessary, we are also lab-certified to perform radon, meth, asbestos and other environmental testing services. See: www.IdahoHomeInspectors.biz/rates for more information.

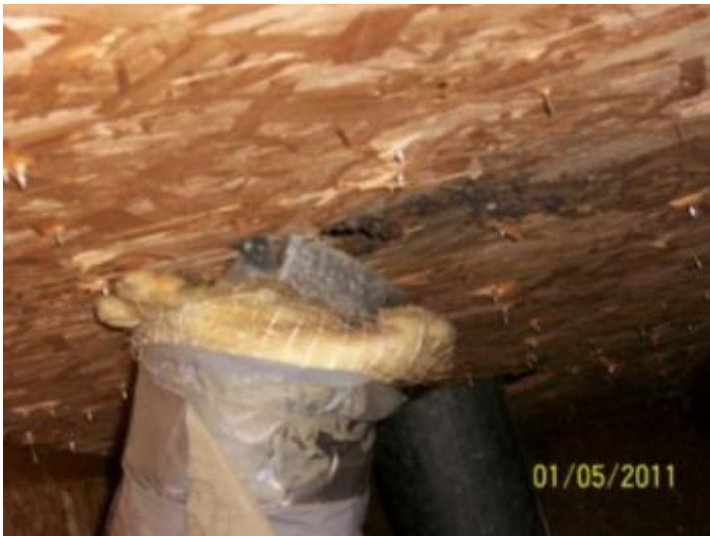
- ATTIC INSULATION:
 - Cellulose Insulation
 - Insulation averages about 10-12 inches in depth
- VAPOR BARRIER:
 - Plastic
- Evidence of past or present leaks, dry at time of the inspection. Monitor for leaks &/or have roofing contractor evaluate.
- Exhaust fan not vented properly in attic. Moisture staining and sheathing deterioration noted.

Exhaust fan not vented properly in attic. Moisture staining and sheathing deterioration noted.

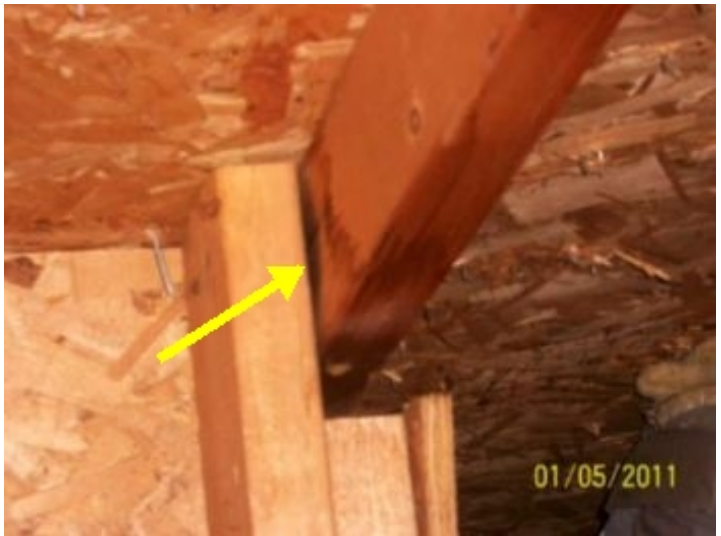
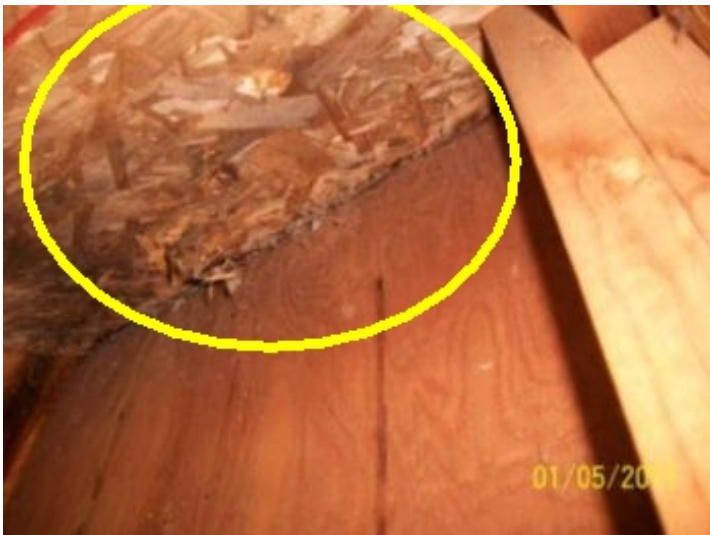
Evidence of past or present leaks, dry at time of the inspection. Monitor for leaks &/or have roofing contractor evaluate.

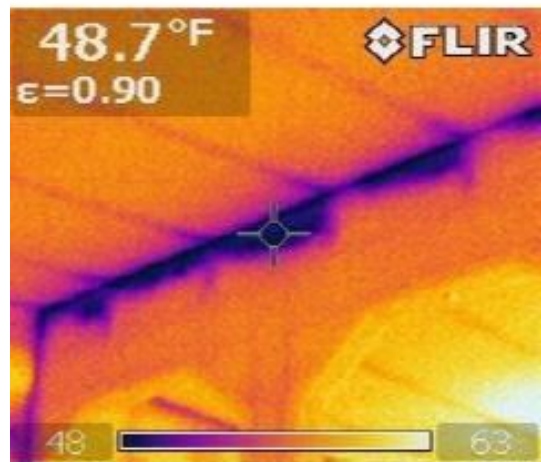
Displaced/Missing areas of insulation in attic at vaulted ceiling

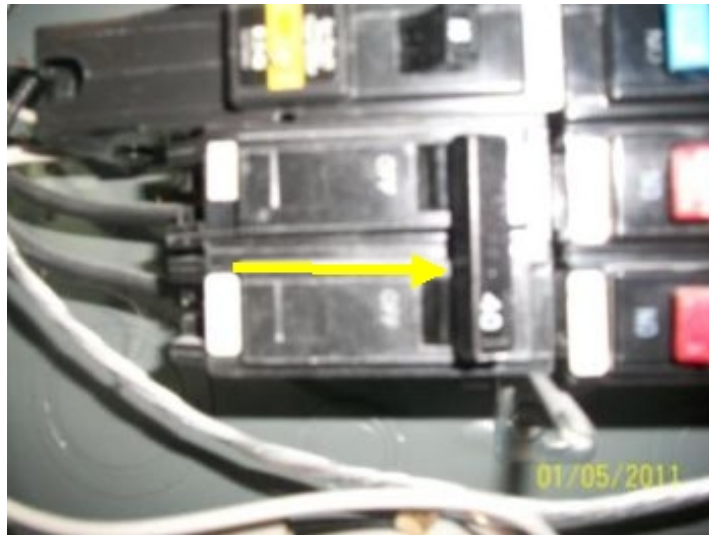
- Inspection of the electrical system revealed need for typical, minor repairs. Although these are not costly to repair, they should be high priority for safety reasons. Be sure to check interior and exterior sections for additional electrical repairs. Consult a licensed electrician
 - **Oversized breaker for AC unit in main panel. See manufacturers recommended size on exterior unit.**

Oversized breaker for AC unit in main panel. See manufacturers recommended size on exterior unit.

- AC unit breaker in main panel oversized. See Electrical Section
- LIMITATIONS:
- Outdoor Temperatures Prevented AC testing. Air Conditioning should not be started at temperatures below 65 degrees. Below this temperature damage can occur to the unit or system.
- AIR CONDITIONING:
- Maintenance Tip: Recommend that HVAC professional seasonally check the air conditioning unit, and ensure the unit is level. This can be accomplished at the same time as the annual furnace inspection.

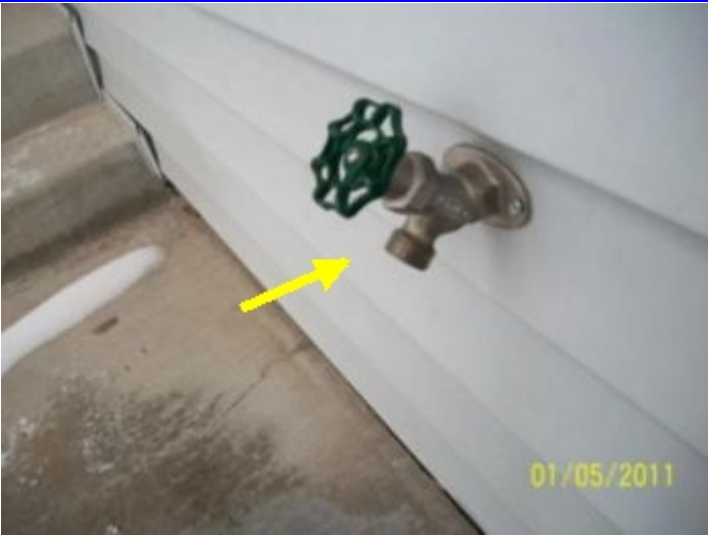
Need Anti-Siphon on exterior bibs

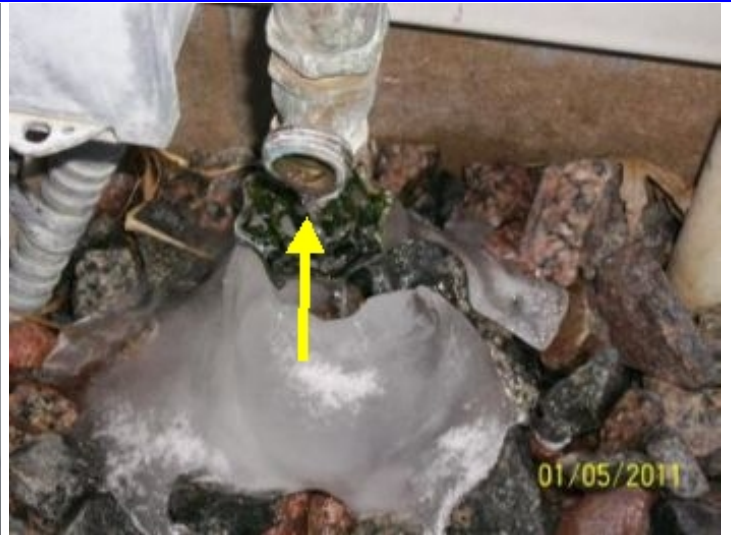
Hose Bib Leaking

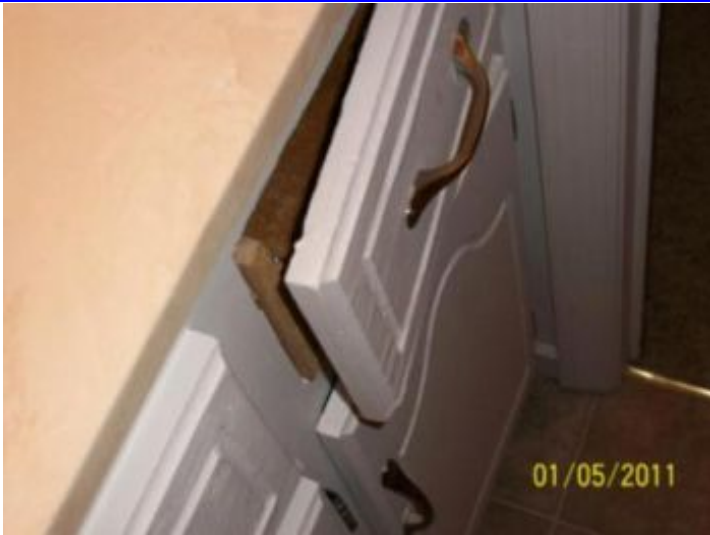
Vanity damaged.

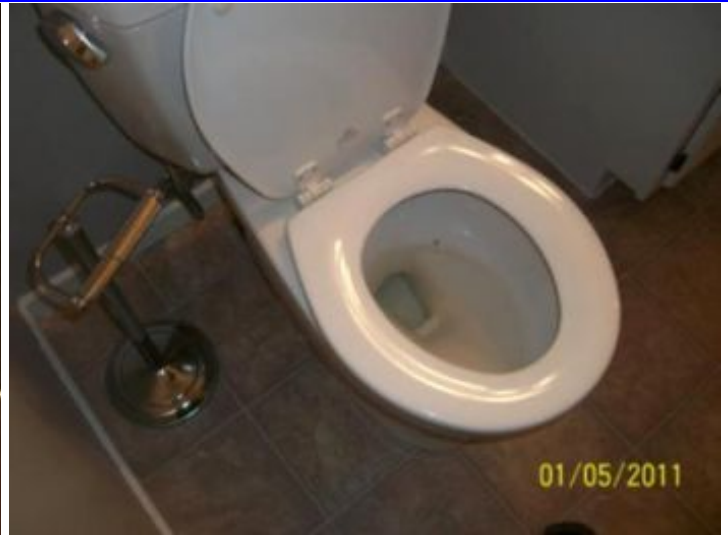
Toilet loose; recommend having re-anchored.

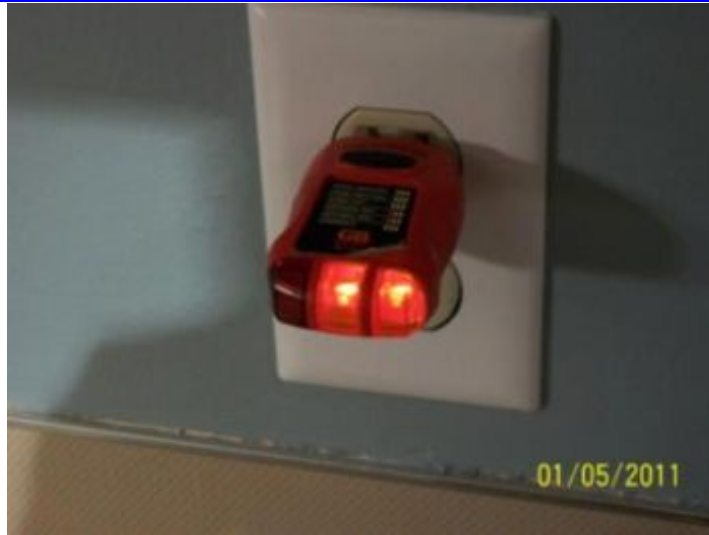
- LOCATION:
- Kitchen
- GFCI needed within 6 feet of water source. Need to install GFCI for safety

GFCI needed in kitchen within 6 feet of water source. Need to install GFCI for safety

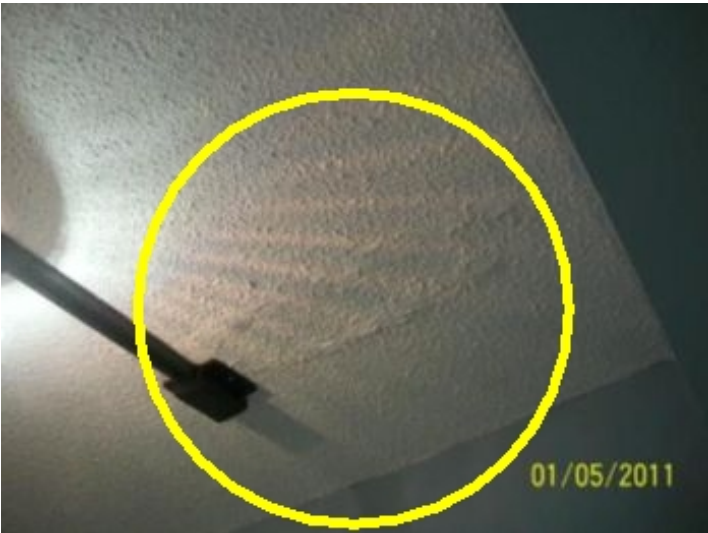
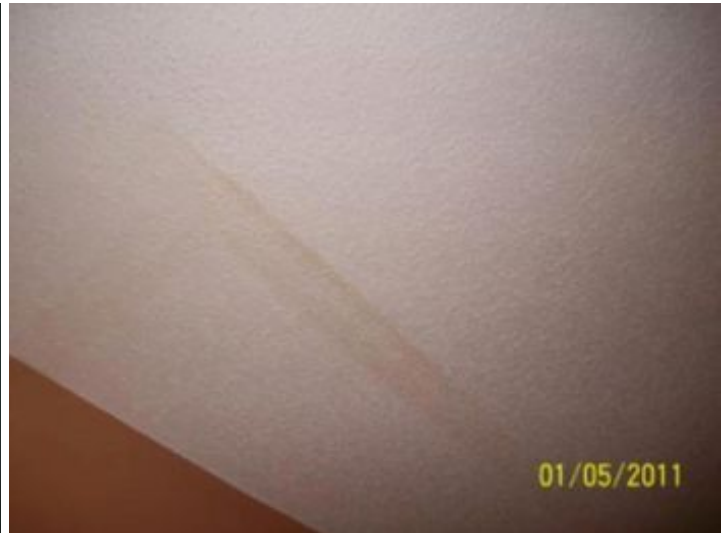
Prior Moisture Ceiling Staining- Tested Dry at time of inspection. Monitor for leaks!

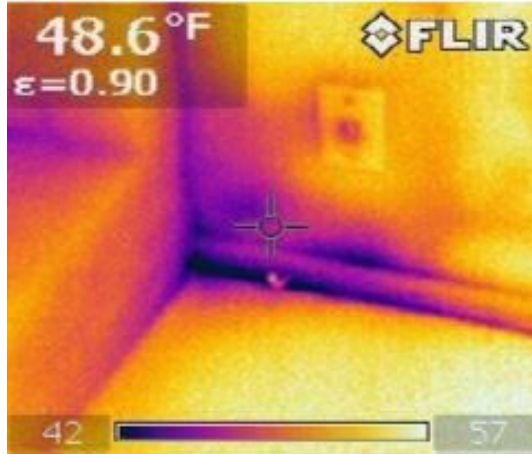
Low level of missing insulation in bedroom upper level

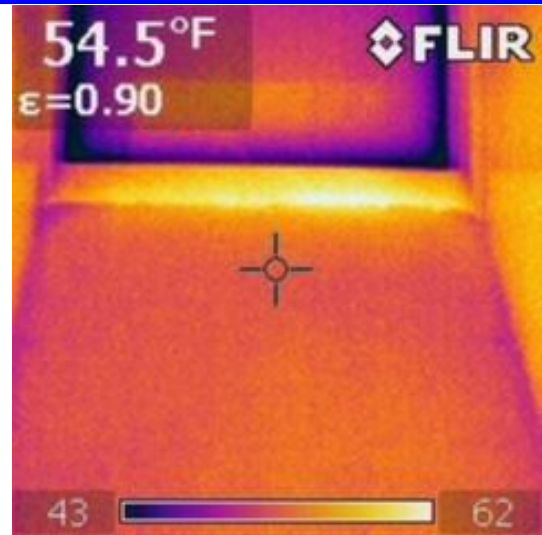
No Evidence of water leak under skylight at time of inspection

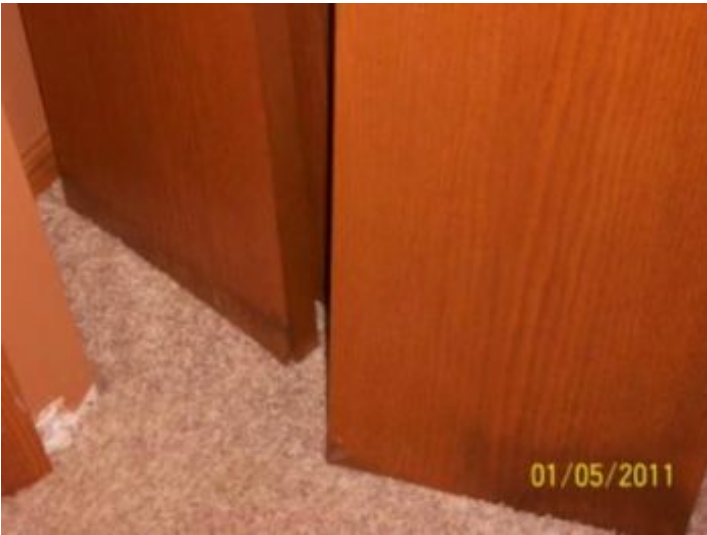
Bedroom Closet doors damaged

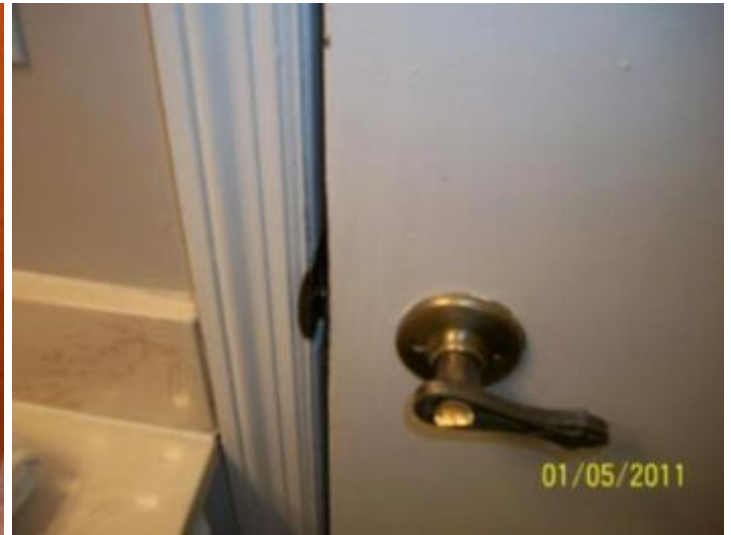
- Door doesn't latch properly upper level bathroom
- LOCATION:
 - Bathroom
 - Garage
- TYPE
 - Wood Hollow Core
 - Sliding Doors
- Door Adjustment needed, Door doesn't latch properly.

Door doesn't latch properly upper level bathroom

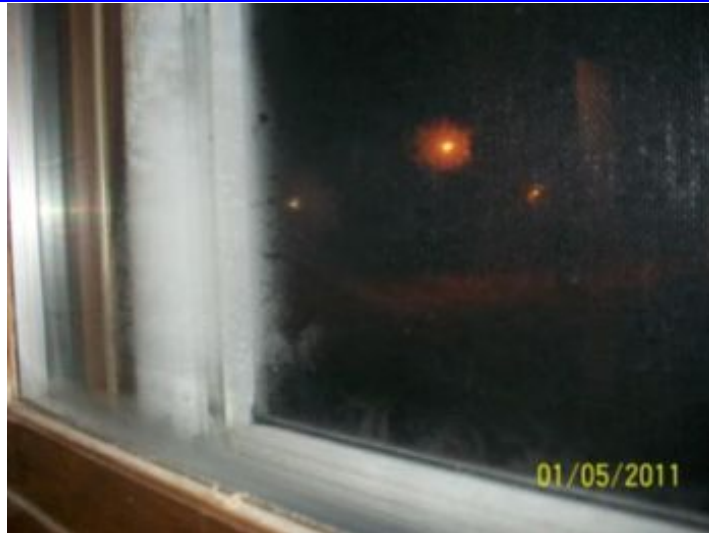
- MATERIAL:
 - Wood
- LOCATION:
 - Living Room East window
- GLASS:
 - Condensation present in some double-paned windows, indicating a broken gas seal.
- SCREENS:
 - Some window screens missing and some damaged.

Condensation present in some double-paned windows, indicating a broken gas seal.

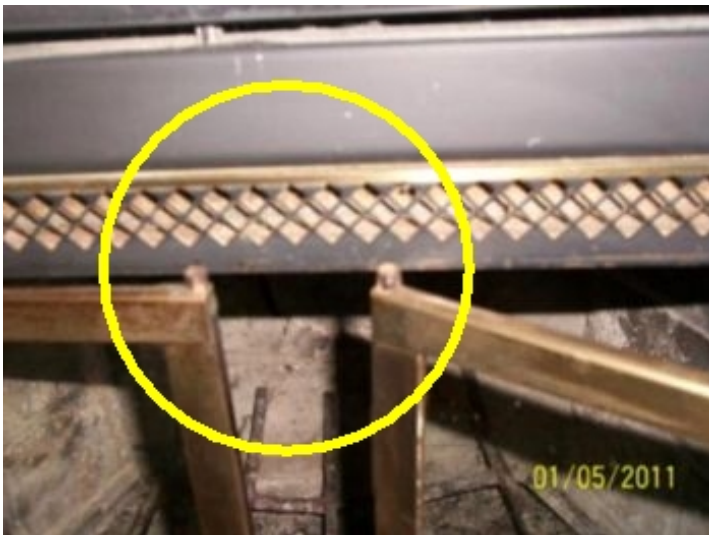
Fireplace Glass/Doors need cleaning & improvement

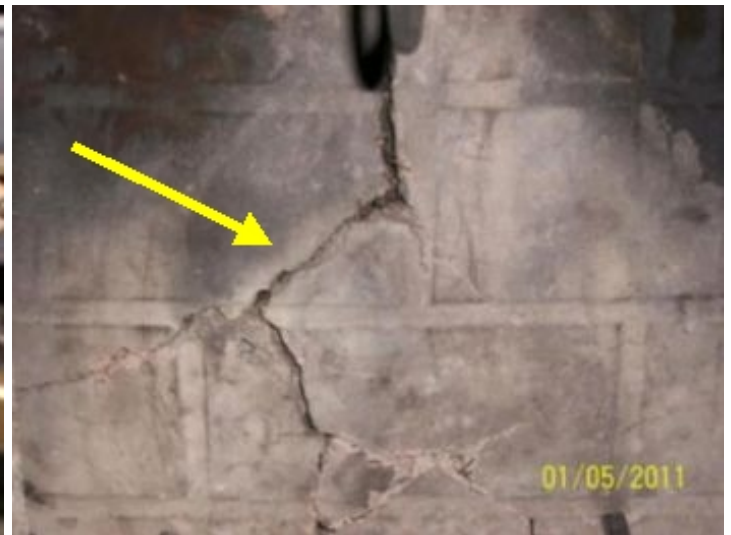
Rear wall of fireplace box damaged, needs repair for safety.

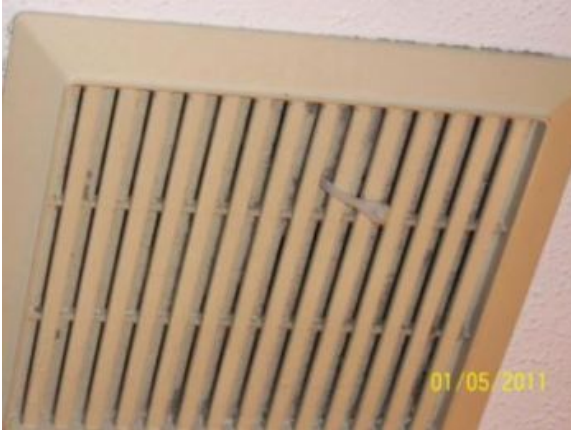
Clean bathroom fans

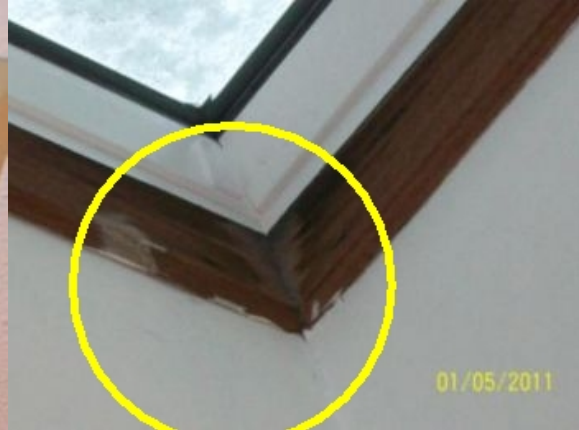
Skylight Moisture Staining. Area dry at time of inspection. Monitor
