7 County Home Inspection, LLC Home Inspection Report

2345 Anywhere Street, Meridian, ID 83646 Inspection prepared for: Jerry Doe & Samantha Doe Date of Inspection: 8/8/2014 Time: 1pm Age of Home: 2005 Size: 2510 Weather: Sunny

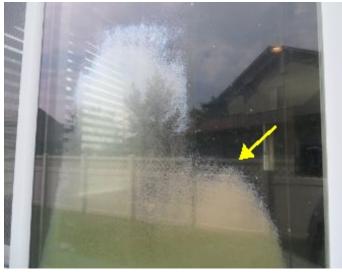
| EXTERIOR AREAS | | | | | |
|---|---|--|--|--|--|
| Page 22 Item: 9 | Windows | Kitchen window over sink (east side) has broken seal and fogging. Consult with window contractor on repair Entry Family Room front right window (from inside home) does not function correctly. Binds and is loose. tracks move and appear to be damaged. Consult with window contractor on repair | | | |

| 9. Windows | |
|---|--|
| | Observations: • MATERIAL: • Vinyl • TYPE: • Sliders • Single/Double hung • Upper back west Bedroom blind cord damaged/ string cut • Kitchen window over sink (east side) has broken seal and fogging. Consult with window contractor on repair • Entry Family Room front right window (from inside home) does not function correctly. Binds and is loose. tracks move and appear to be damaged. Consult with window contractor on repair |
